## **Additional Test Report**

**Fire Resistance test in accordance with BS EN 1365-2:2000 on a loaded softwood timber joist floor incorporating fifteen Halers H2 downlights.**

Test report number 260284A

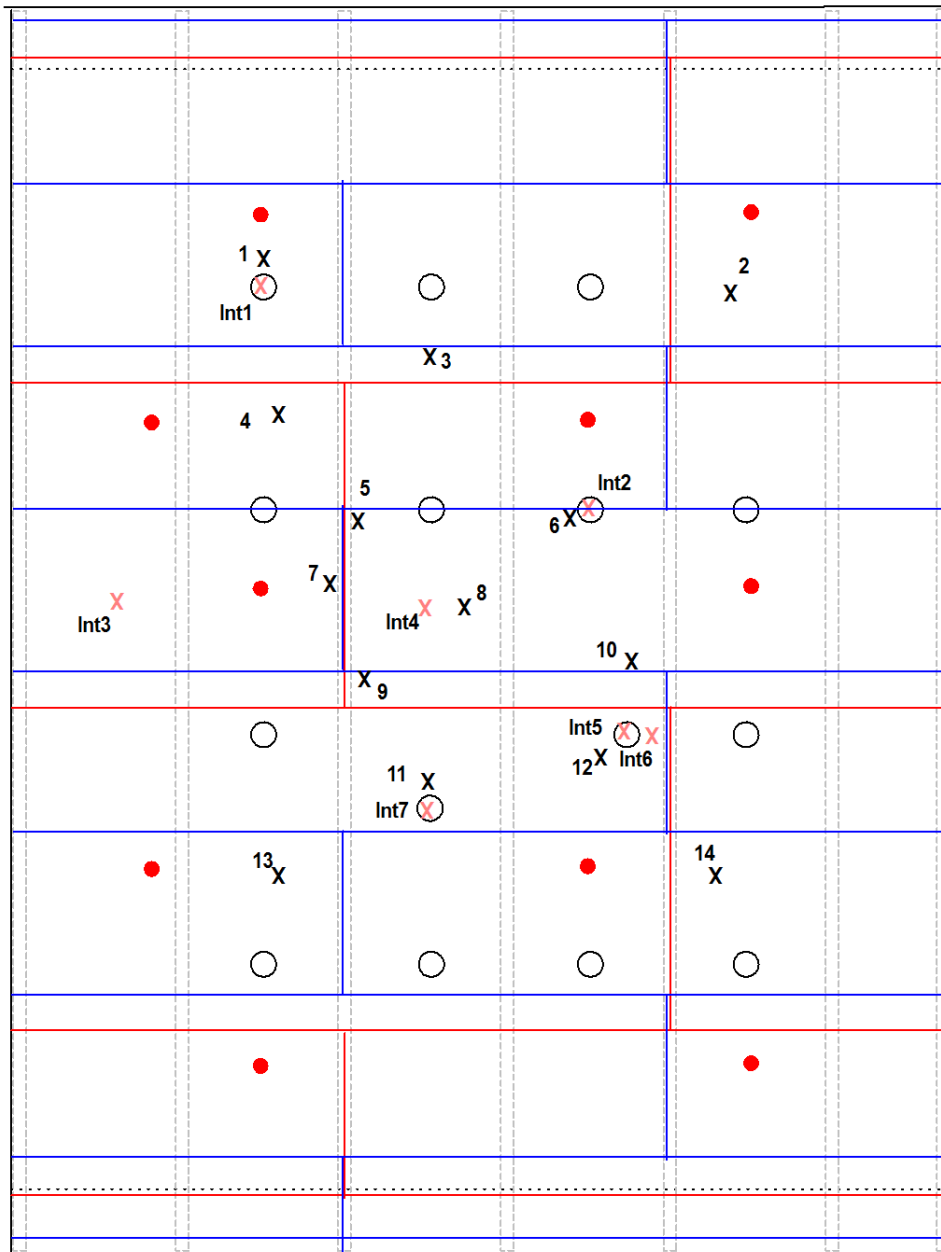
**Figure 2** Schematic showing arrangement of specimen and thermocouples.

X 1-14 Unexposed face thermocouples X Int1- Int7 Internal thermocouples

● Furnace thermocouples ○ Downlighter

— Flooring on unexposed face  
 — Plasterboard on exposed face  
 - - - - - Joists

The furnace temperature was measured by means of ten plate thermometers arranged symmetrically in the furnace, suspended through the floor assembly (with the holes sealed) such that the measuring junctions were set 100mm below the soffit of the floor. The arrangement of the furnace thermometers was as shown in Figure 2.

The temperature on the unexposed face of the floor was monitored by fourteen K-type thermocouples, each soldered to a copper disk and secured using an insulating pad to the upper side of the chipboard. The positions of the thermocouples are detailed in Table 1 below (described when viewed from above) and are also shown in Figure 2:

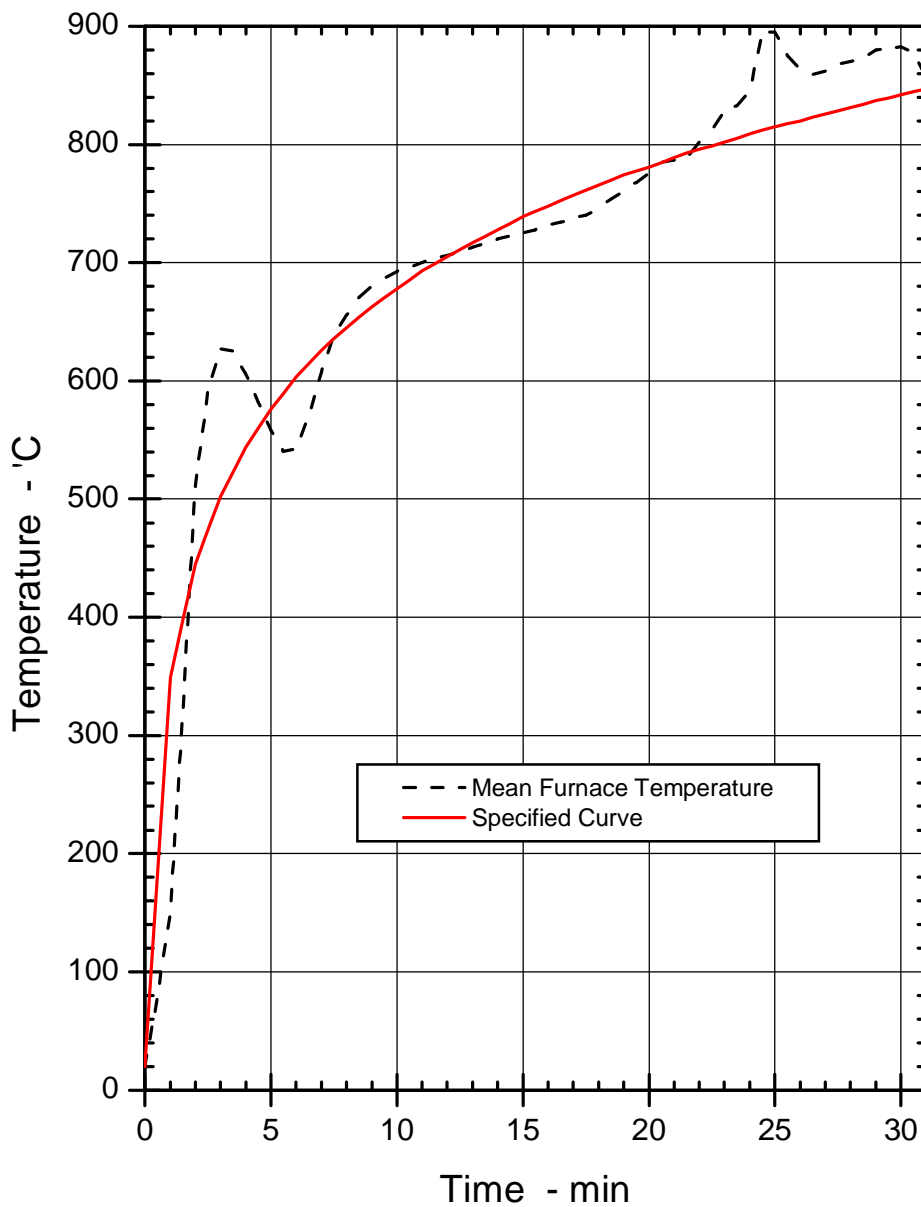
**Graph 1** Furnace temperature.

The mean furnace temperature is shown plotted against time in Graph 1 together with the specified time/temperature curve for comparison. The furnace pressure, measured 100mm below the ceiling, is shown plotted against time in Graph 2.

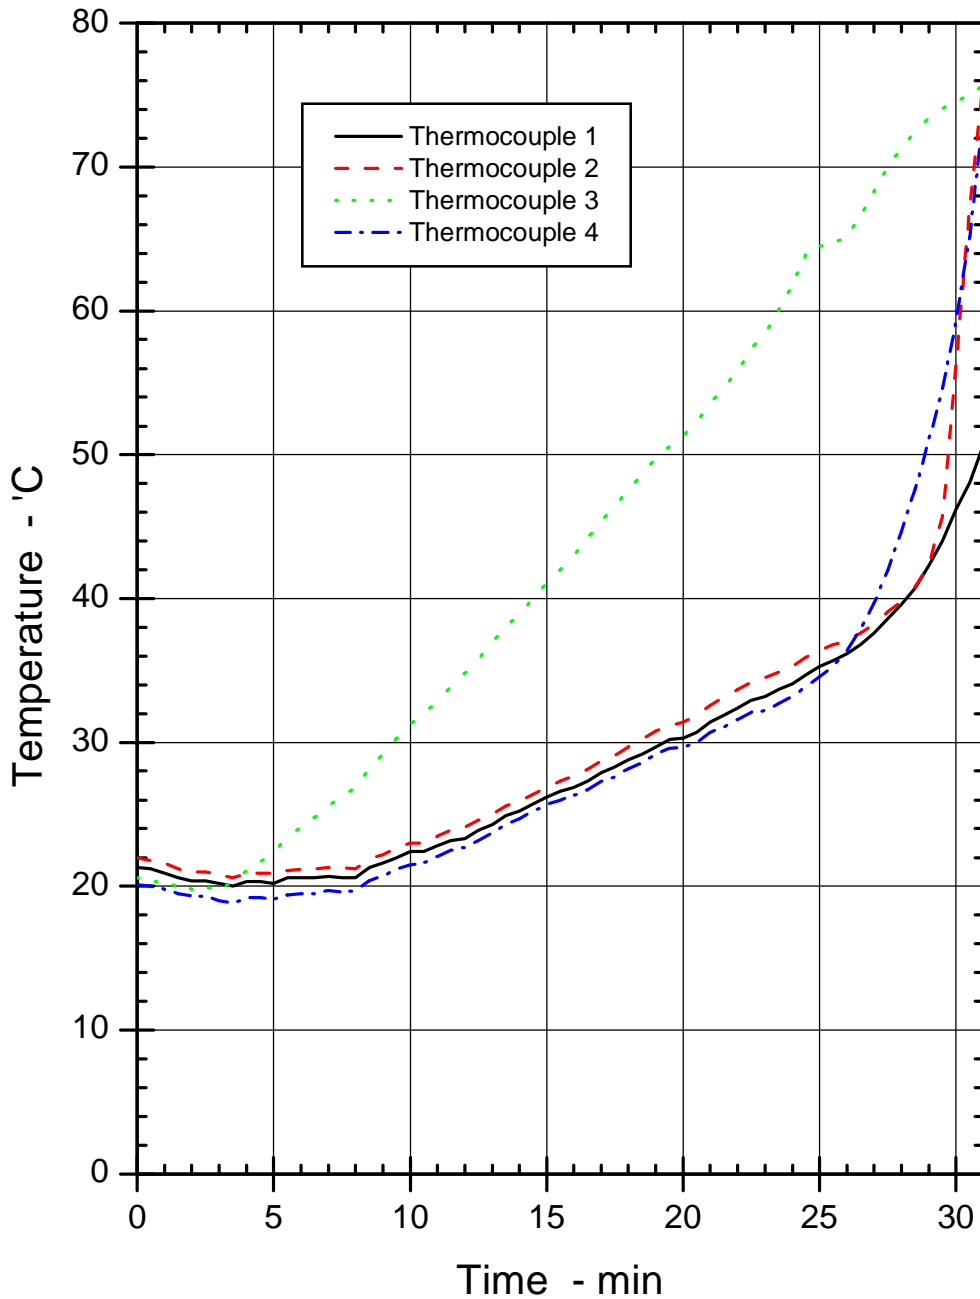
**Graph 4** Temperature recorded by thermocouples 1 to 4 on unexposed face of floor.

The temperature recorded by individual temperatures on the unexposed face of the floor is plotted against time in Graphs 4, 5 and 6.

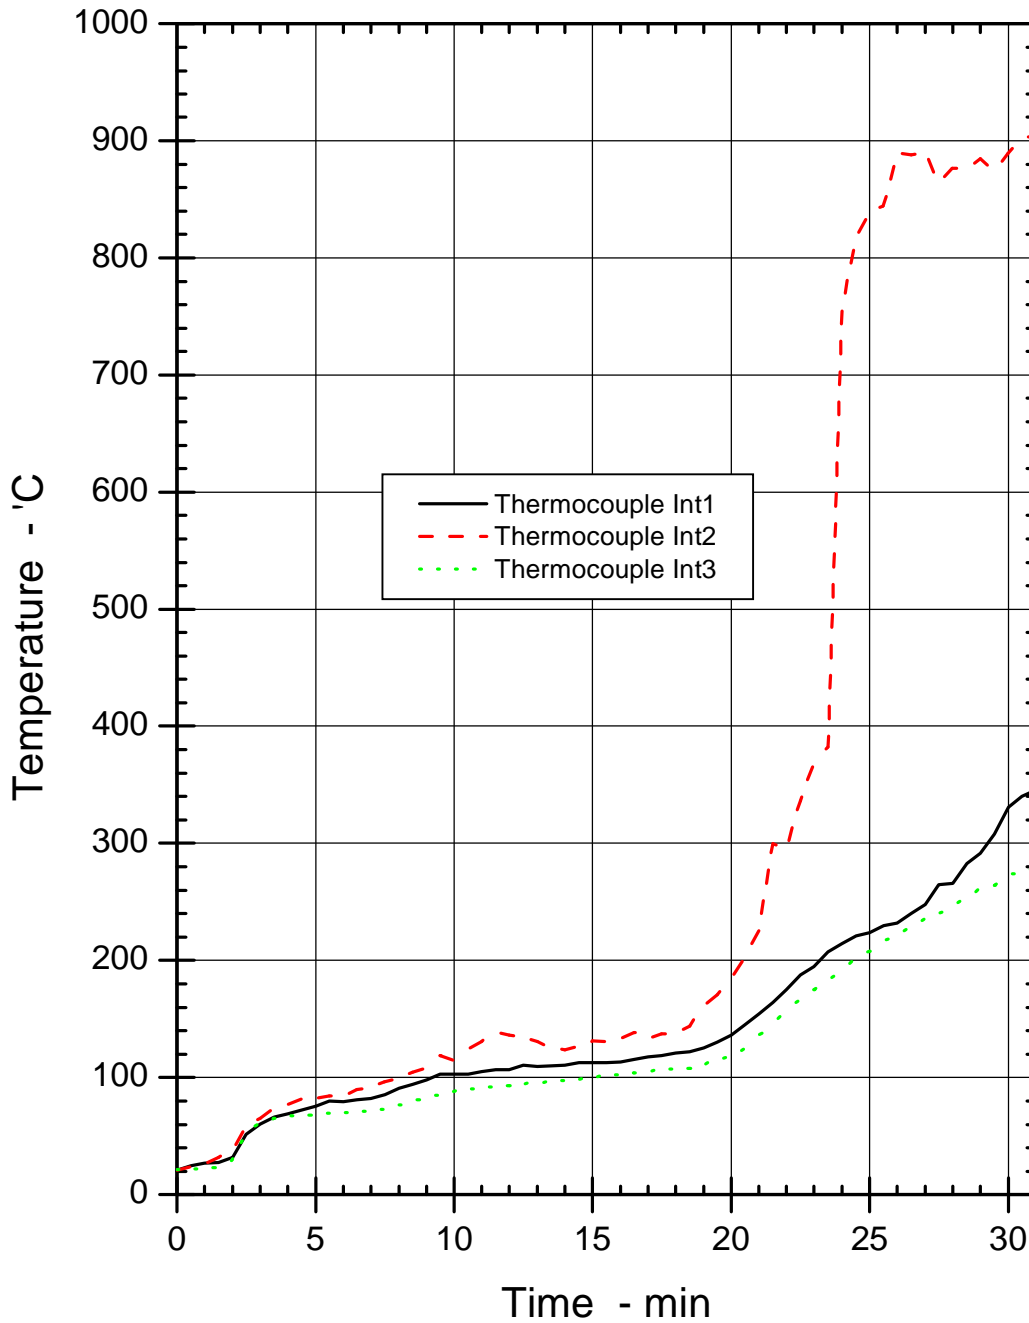
**Graph 8** Temperature recorded by thermocouple Int1 to Int3 in cavity of floor assembly.

The temperature recorded by thermocouples Int1 to Int7, for the sponsor's information only, is shown plotted against time in Graphs 8 and 9.

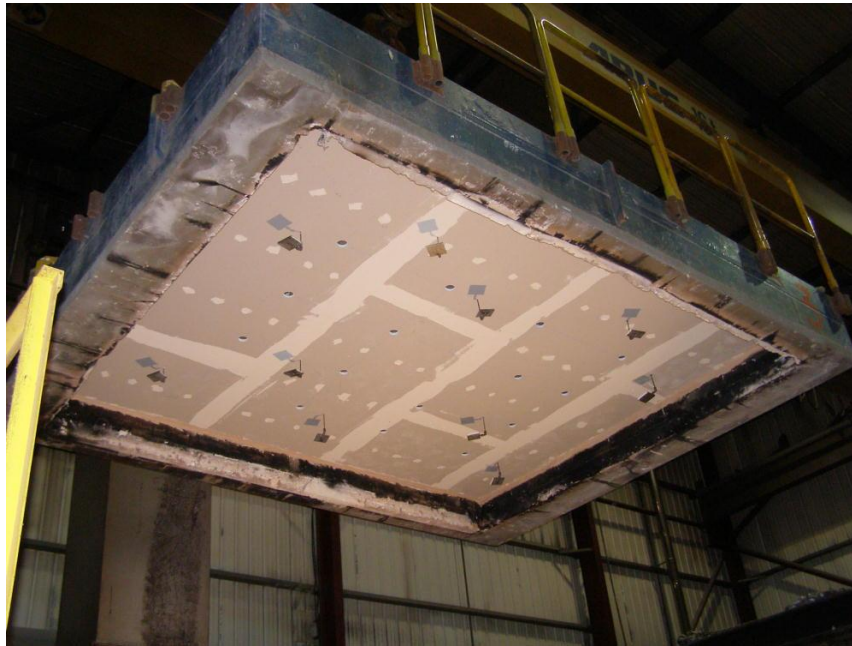
**Plate 1** Test construction being lifted onto furnace before test, showing holes drilled in ceiling prior to installation of downlights.

BRE installed the downlights through 65mm-diameter holes made in the ceiling. The downlighters were inserted through the apertures and retained in place by their integral retaining springs. The downlighters were not connected to any electrical cables.

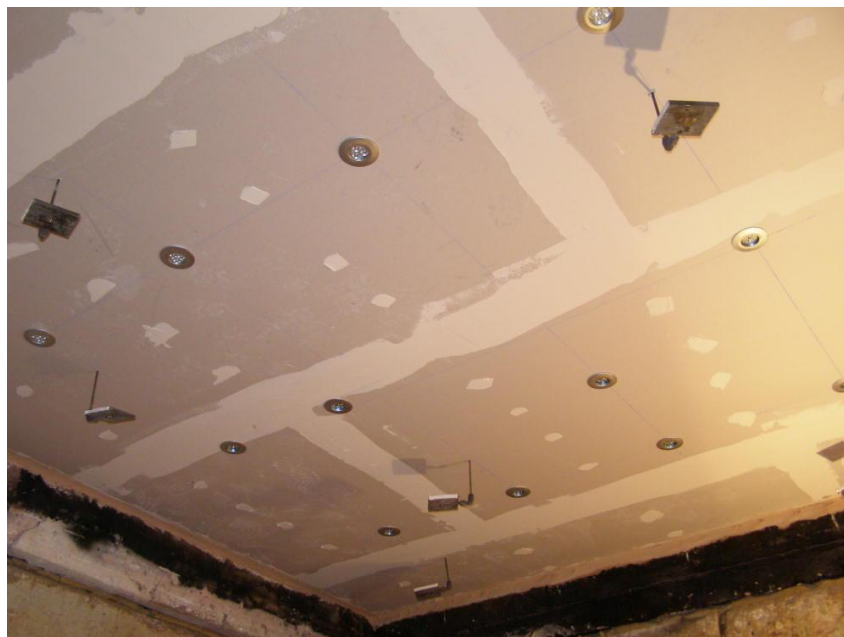
**Plate 2** Exposed face of test construction before test showing downlights installed.

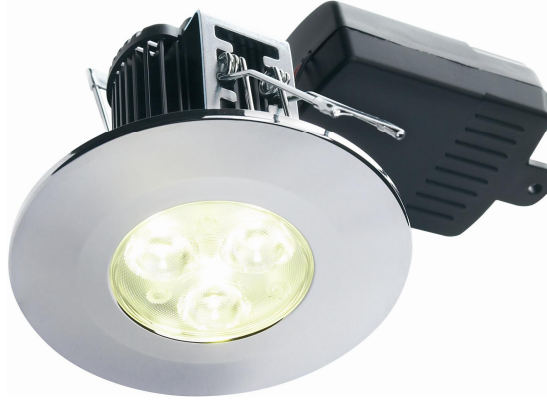
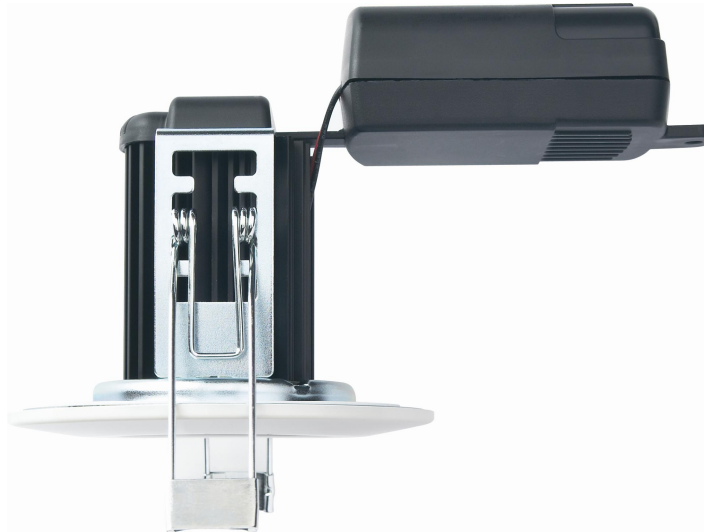
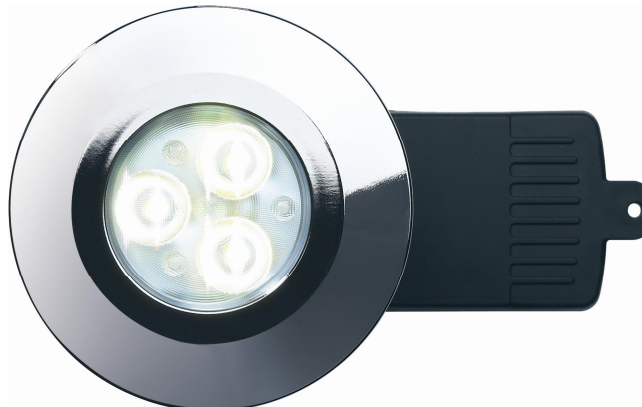
**Plate 3** Halers H2 downlight as used in test construction.

Details of the fittings, which had a white finish, are shown in Figure 3. The fittings, before test are shown in Plates 2 and 3.

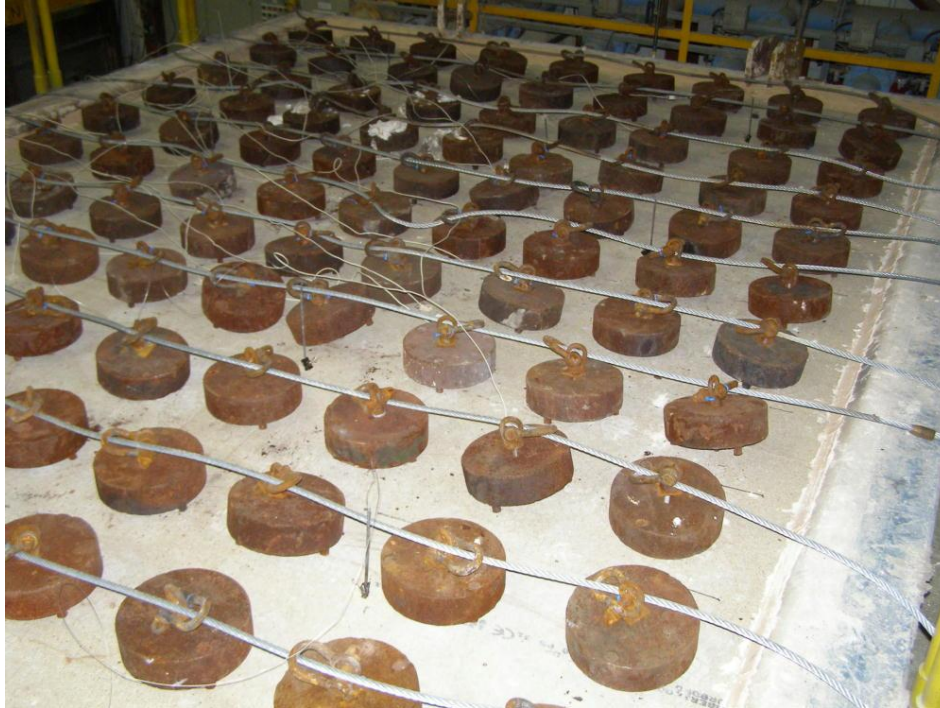
**Plate 4** Unexposed face of test construction before test.

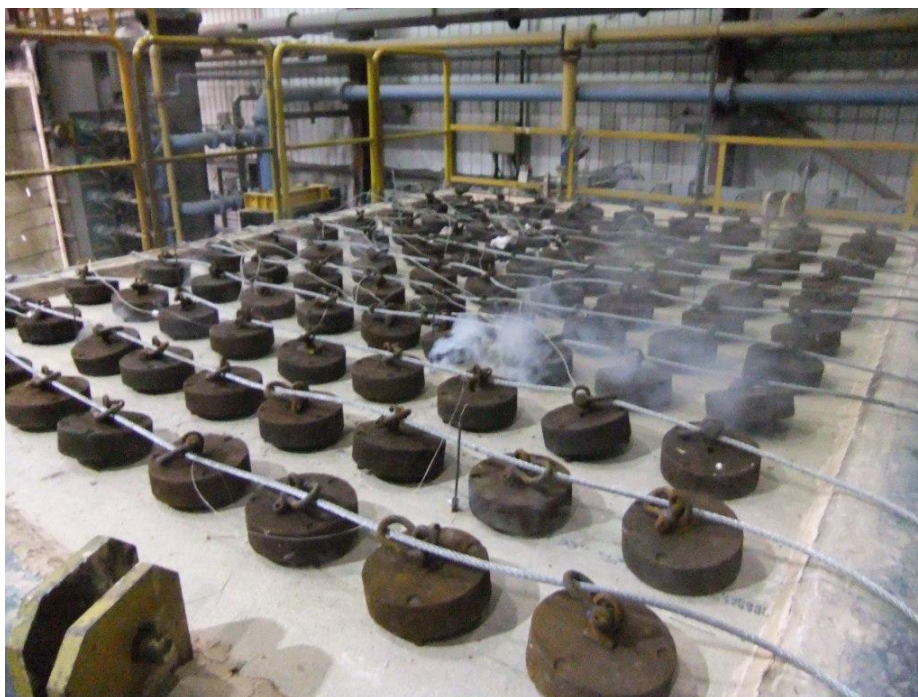
**Plate 5** Unexposed face of test construction after approx. 22 minutes from start of test.

22:00	On unexposed face very slight unevenness in surface of floor. Plate 5.
22:30	Large section of plasterboard ceiling falls away from area under location of thermocouples 12 and 14 (See A in diagram above); flames issuing from voids between joists.

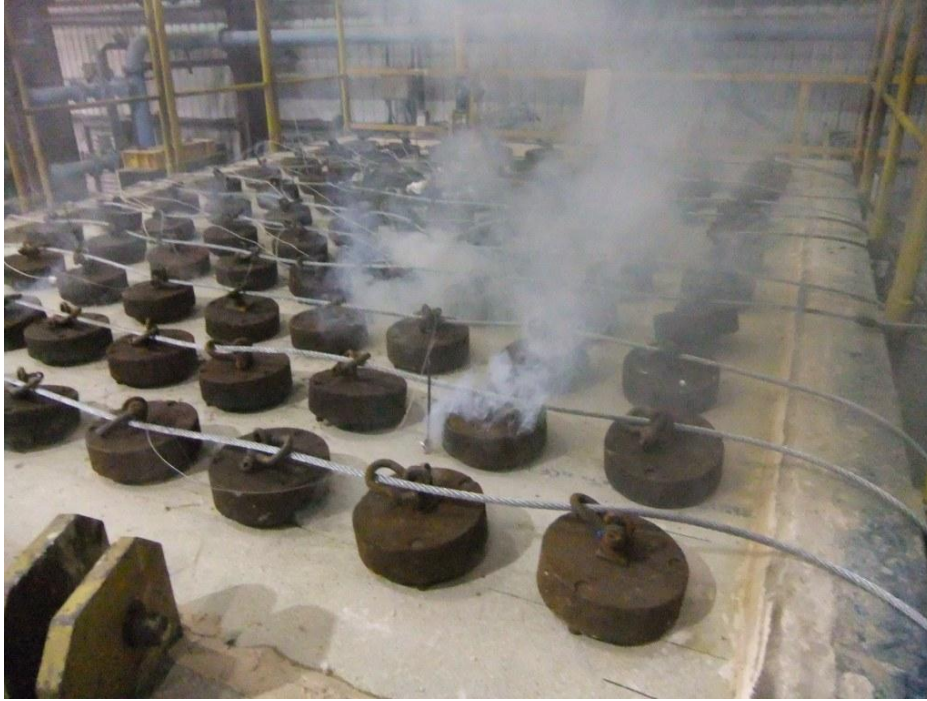
**Plate 6** Unexposed face of test construction after approx. 26 minutes from start of test.

24:00	Other pieces of plasterboard ceiling fall away, copious flames issuing from void prevent a view of the exposed face of the test construction.
26:00	On unexposed face slight quantities of smoke issuing from join between chipboard flooring in vicinity of thermocouple 12 (See B in diagram above).

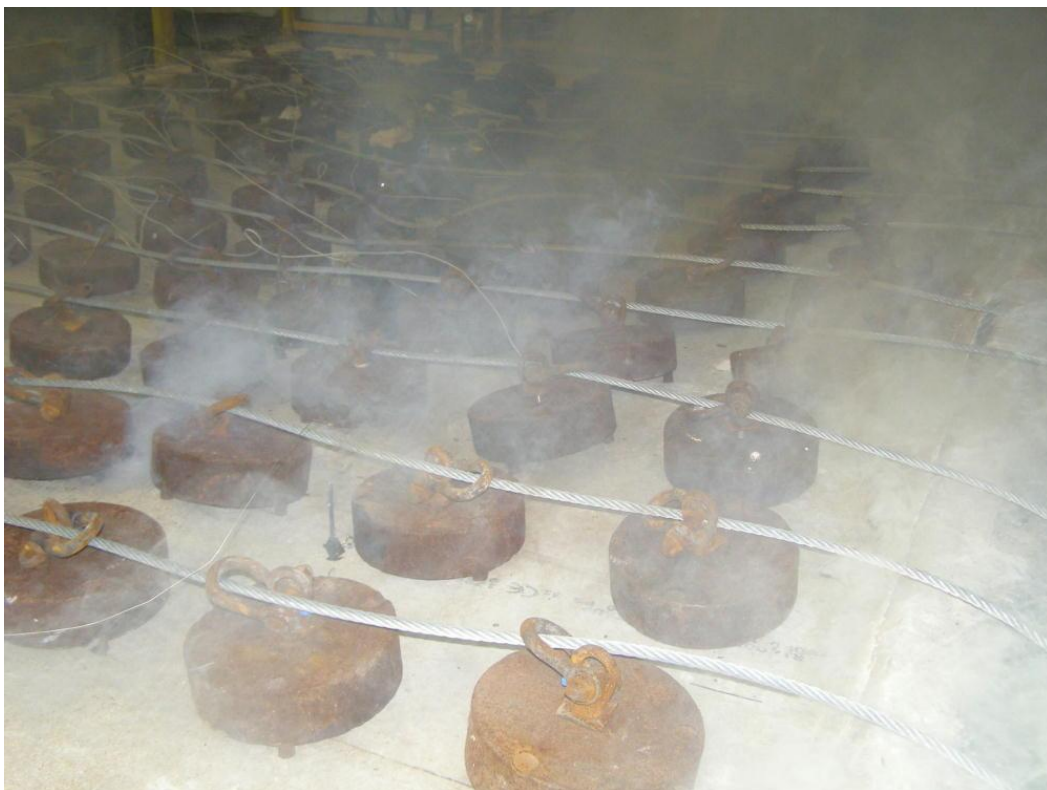
**Plate 7** Unexposed face of test construction after approx. 30 min from start of test.

30:00	Plates 7, 8..
31:00	Test terminated at sponsor's request

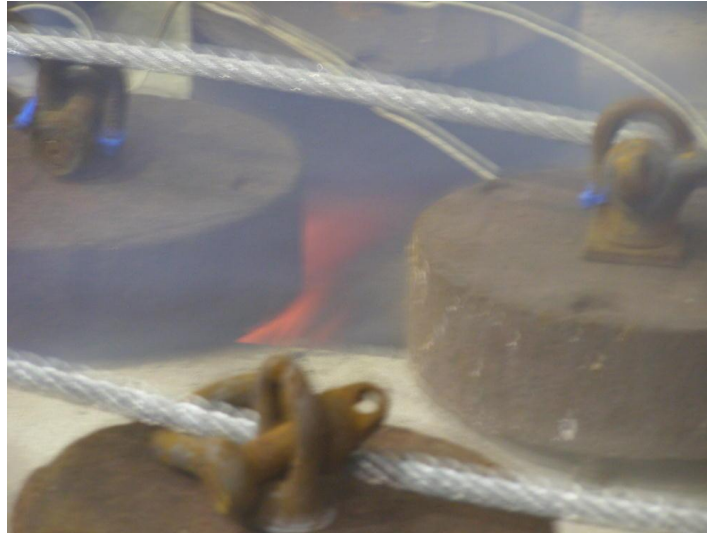
**Plate 8** Unexposed face of test construction after approx. 30 min showing flaming in vicinity of thermocouple 12.

29:39	On unexposed face sustained flaming from join between chipboard flooring in vicinity of thermocouple 12 (See C in diagram above) - Failure of integrity.
